109546 Verification report

Results
Results from corrosion resistance test

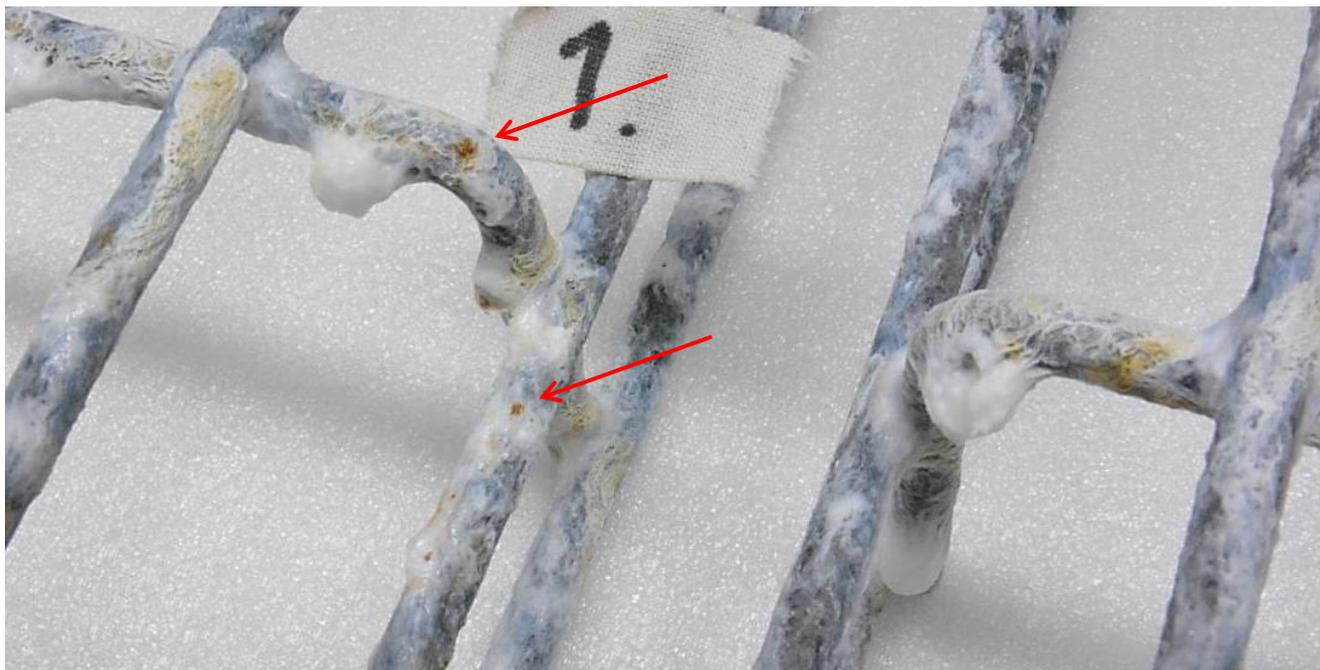
Picture 11. Close-up picture on sample 1 after 240h of testing. Example(s) of base metal corrosion is marked with arrow(s).

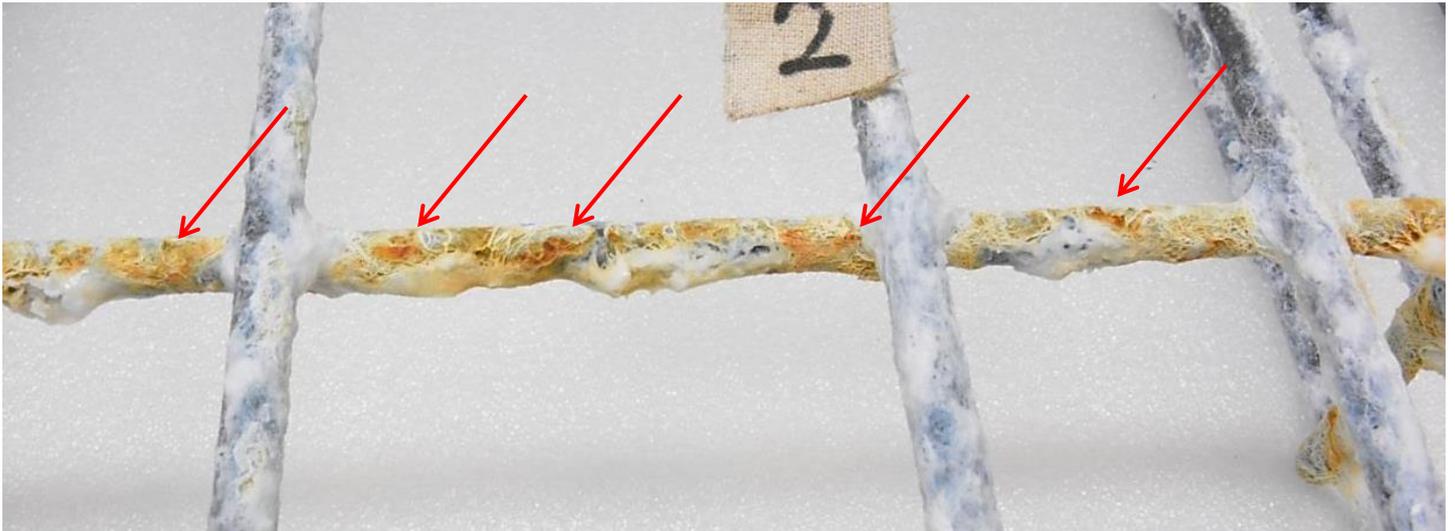
Picture 14. Close-up picture on sample 2 after 504h of testing. Example(s) of base metal corrosion is marked with arrow(s).

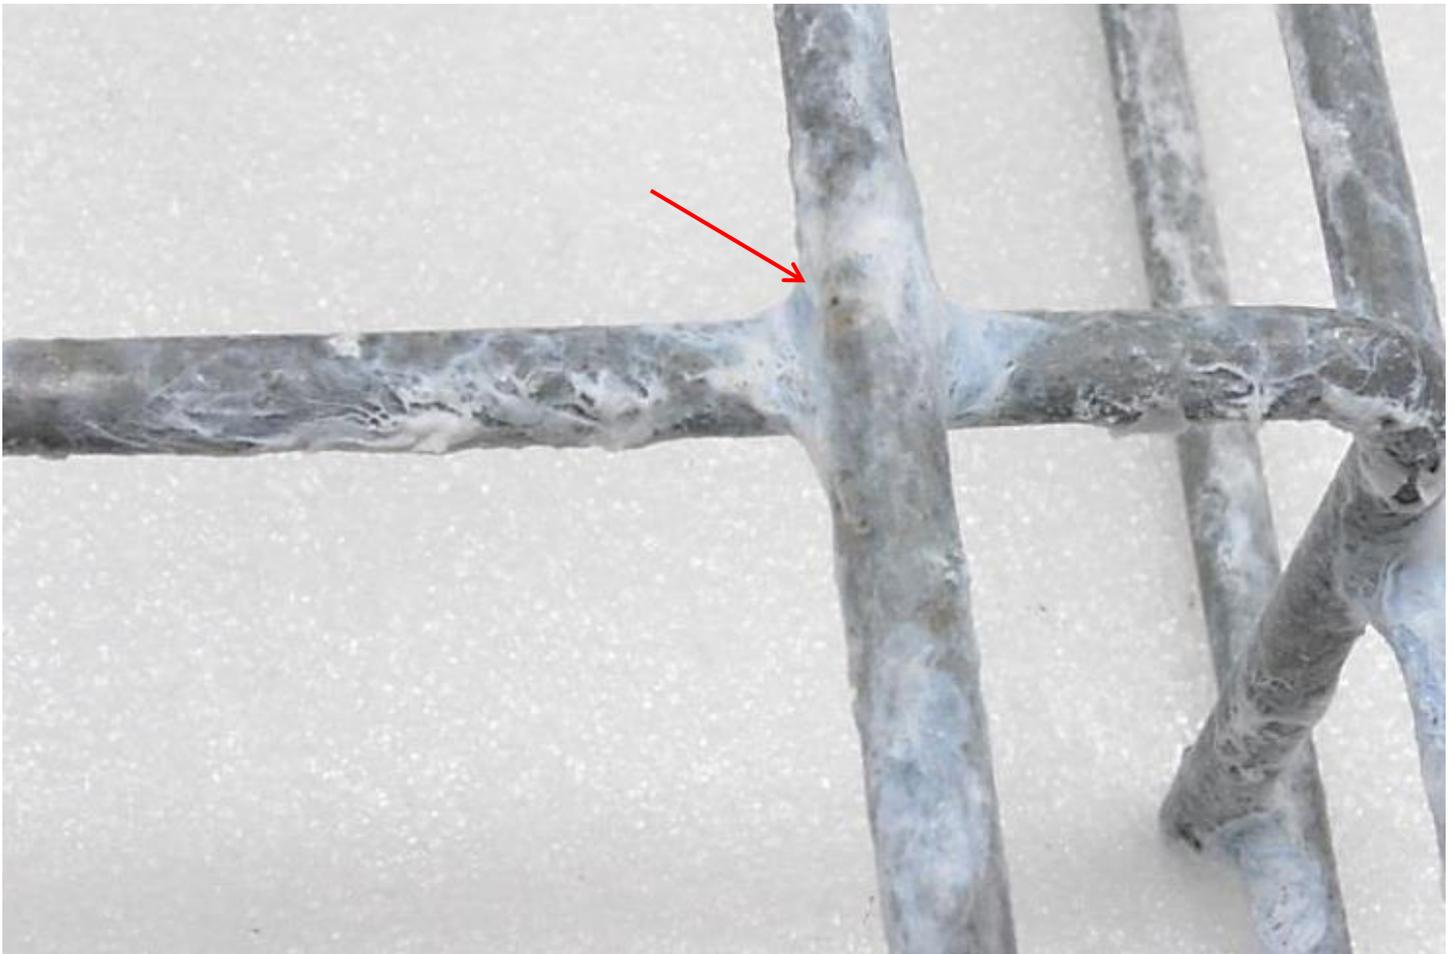
Picture 15. Close-up picture on sample 4 after 504h of testing. Example(s) of base metal corrosion is marked with arrow(s).
