MFPA Leipzig GmbH

Test report no. PB 3.2/19-244-1

Subject matter: Orienting fire test of loaded type "KP" cable clamps in accordance with
DIN EN 1363-1:2012-10 under thermal stress according to the standard
time-temperature curve (ETK) to determine the fire resistance period.

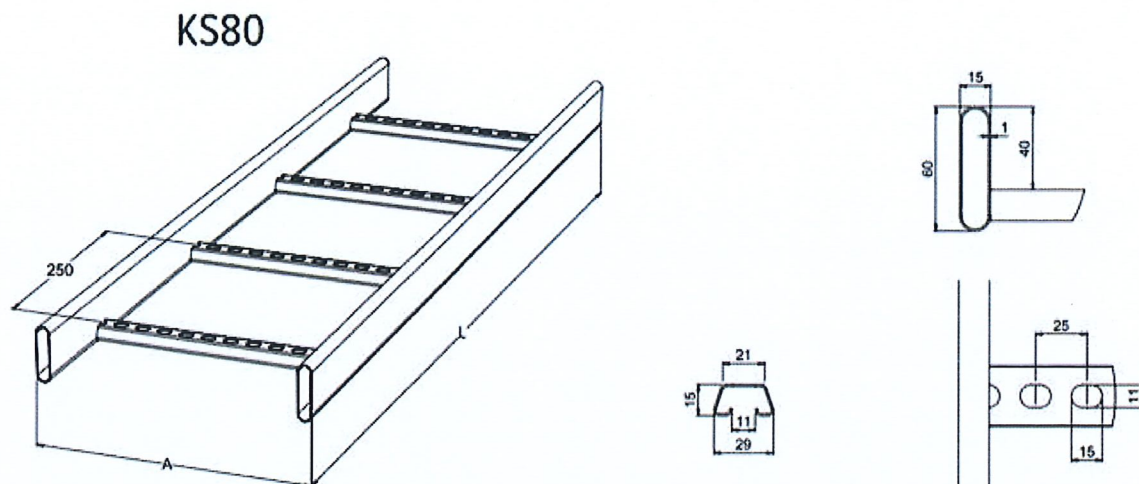
Figure A1.3 Detailed drawing of the cable ladder

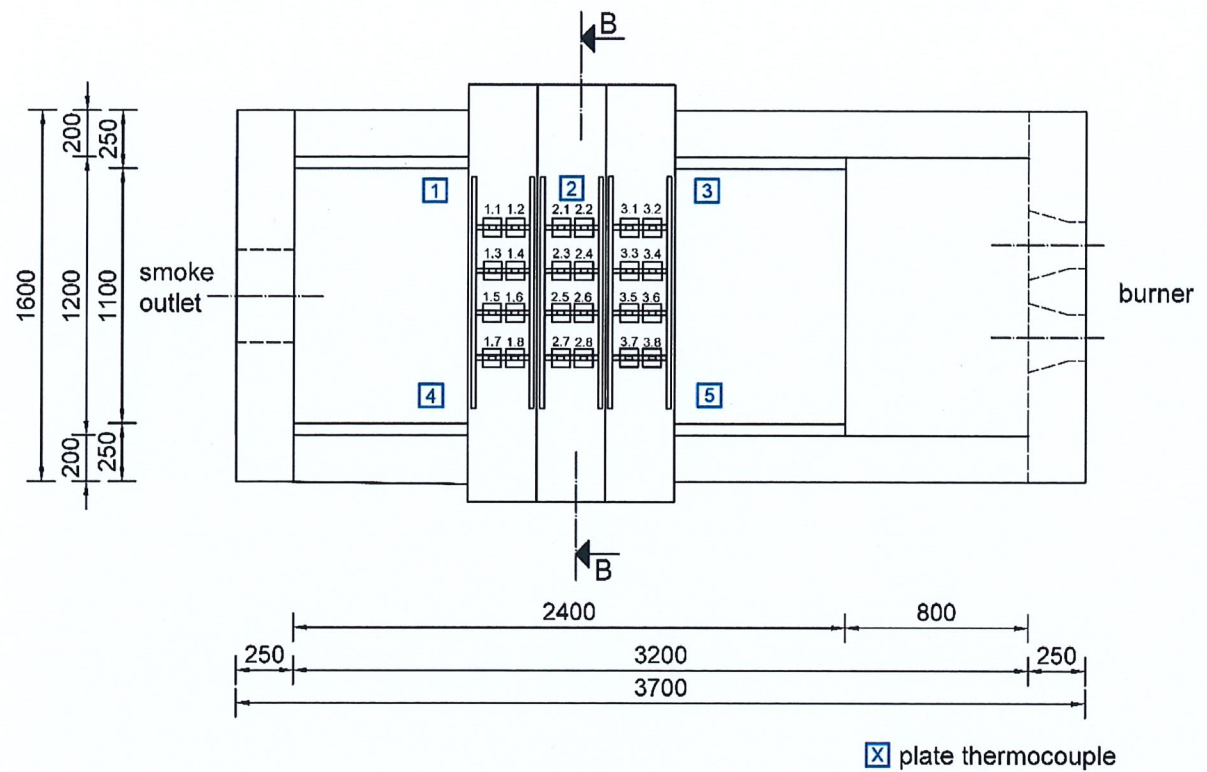
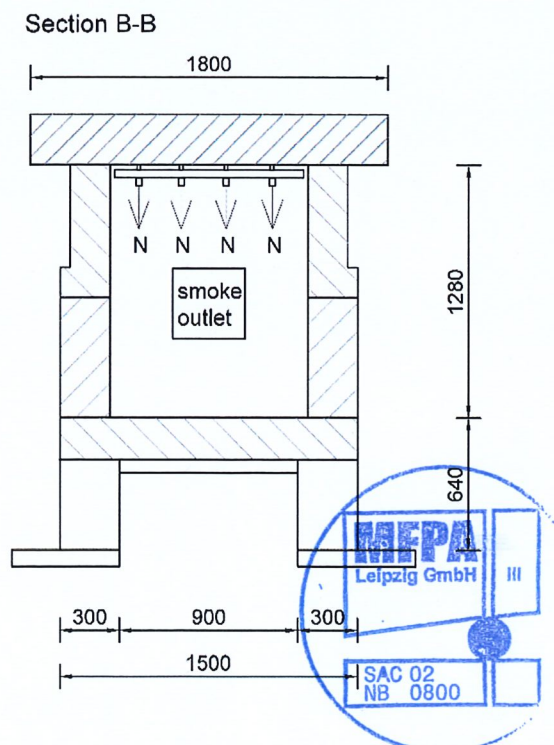
Enclosure 2 Structural design of the testing device and installation situation

The reinforced concrete ceiling section to which the cable ladders were attached using concrete drilling screws formed the upper horizontal space enclosure of the fire chamber during the fire test. After 28 days, the concrete section could be assigned to compressive strength class C 20/25. The positions of the samples in the test furnace are shown in enclosure 2.

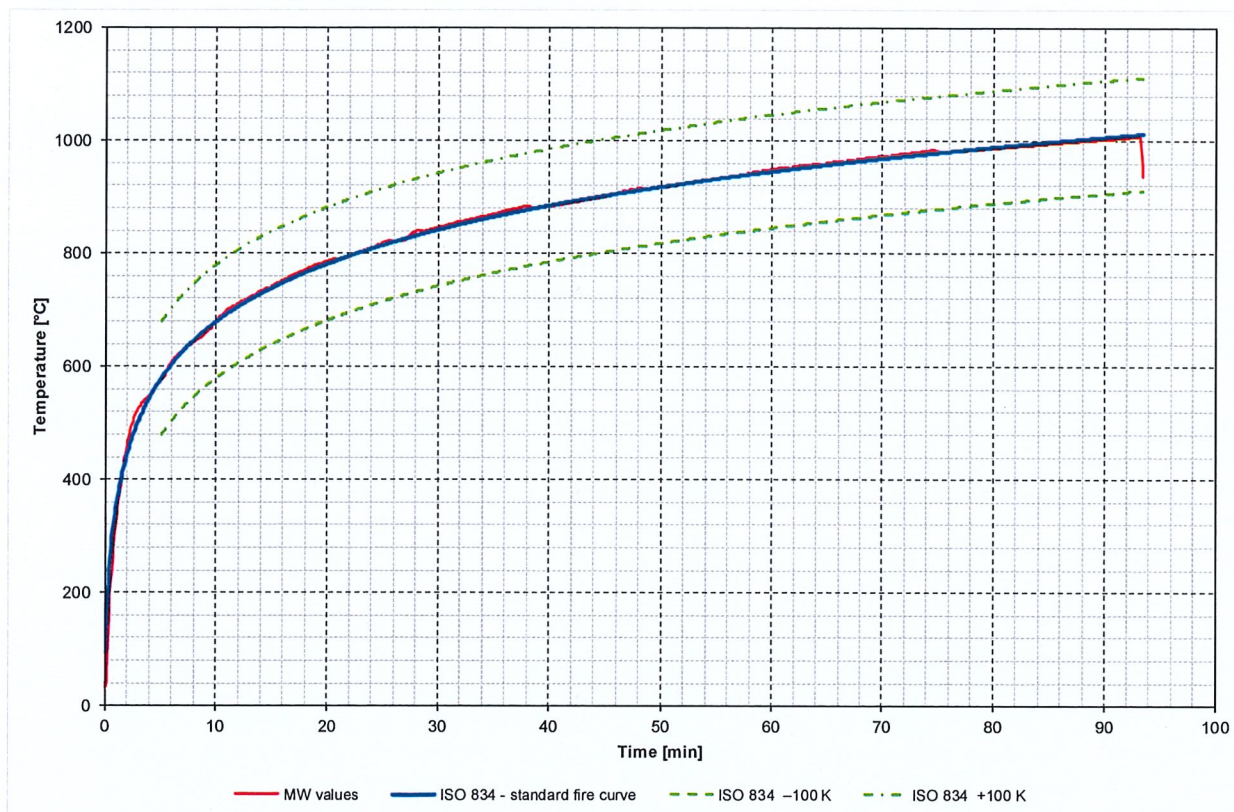
Diagram A3.1 Temperatures in the fire area

To verify the temperatures in the fire area, five plate thermometers in accordance with DIN EN 1363-1:2012-10 [1], section 4.5.1.1, were installed in the fire chamber at a distance of 150 mm to the reinforced concrete ceiling to control the fire area temperature. All fire area temperatures were measured and recorded at intervals of 5 seconds. The temperatures which were measured in the fire chamber during the fire test are graphically analysed in enclosure 3.

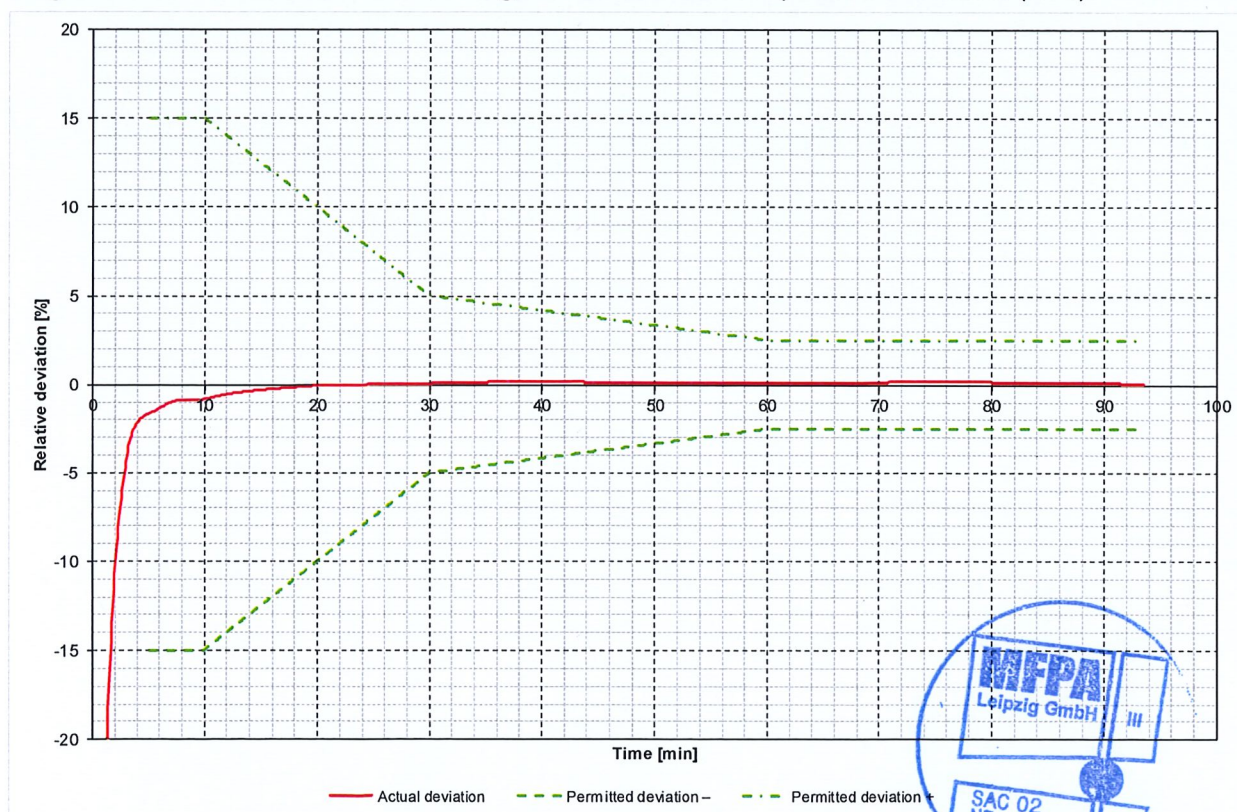
Diagram A3.2 Deviation from the integral of the standard temperature-time curve (TTC)

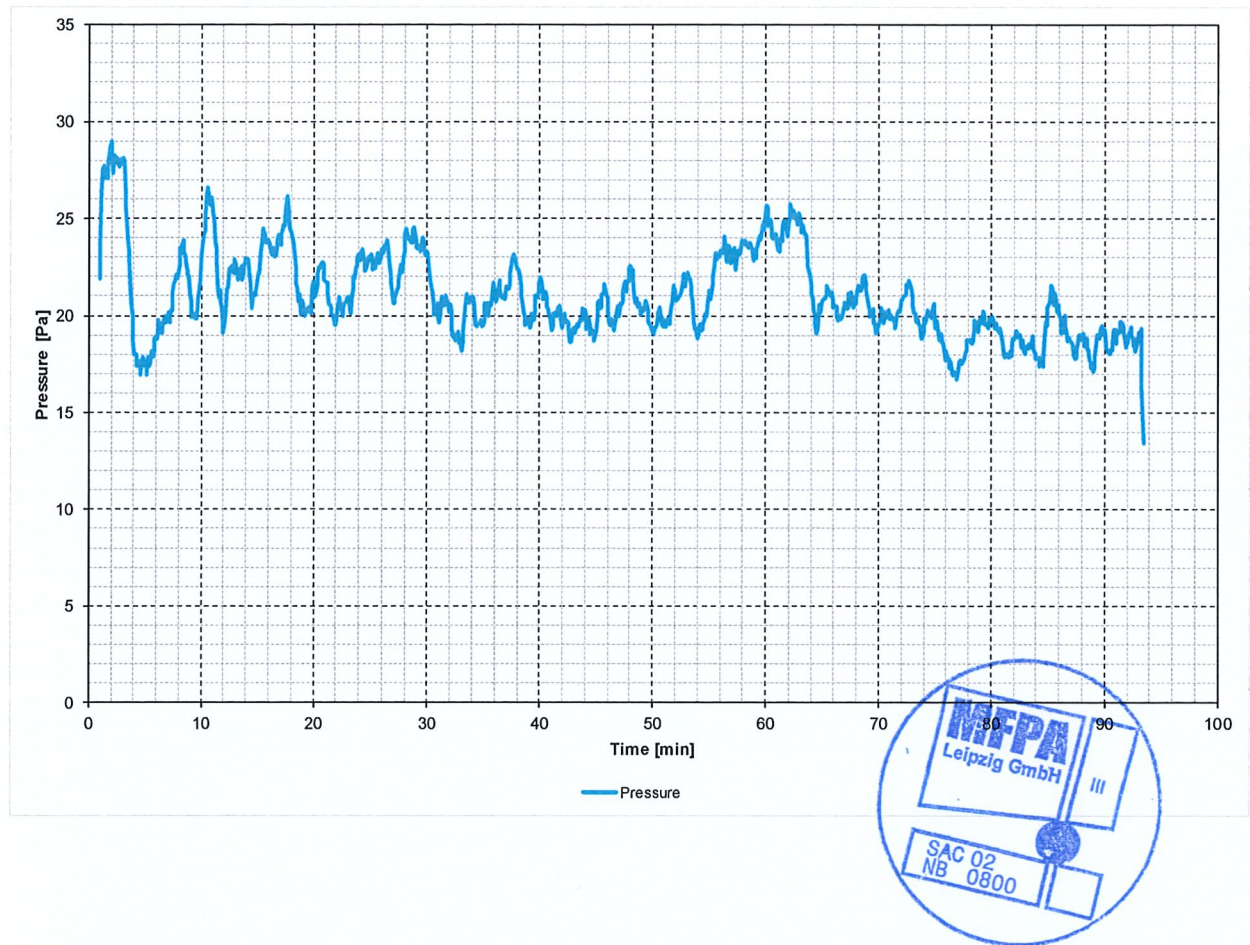
Diagram A3.3 Pressure in fire area

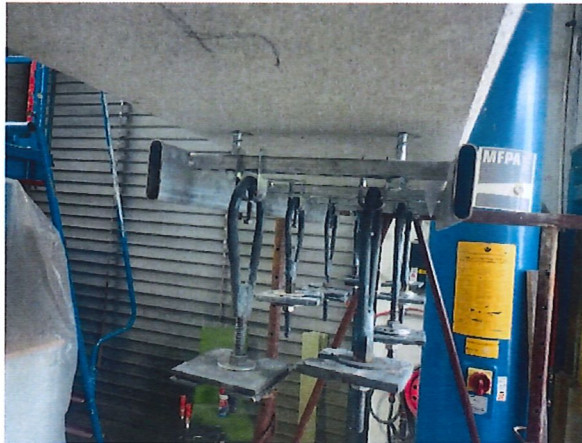
Figure A4.1 View of the test set-up.

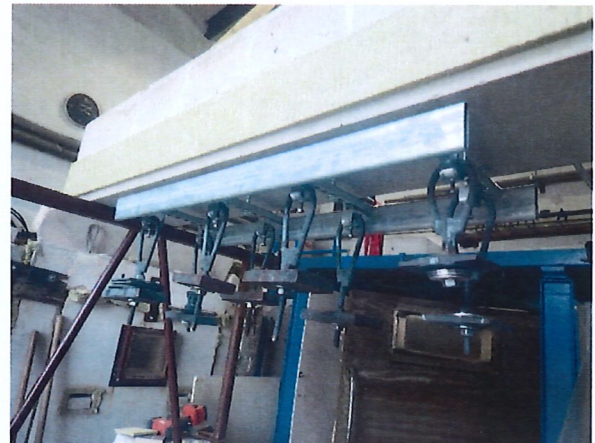
Figure A4.2 View of the test set-up.

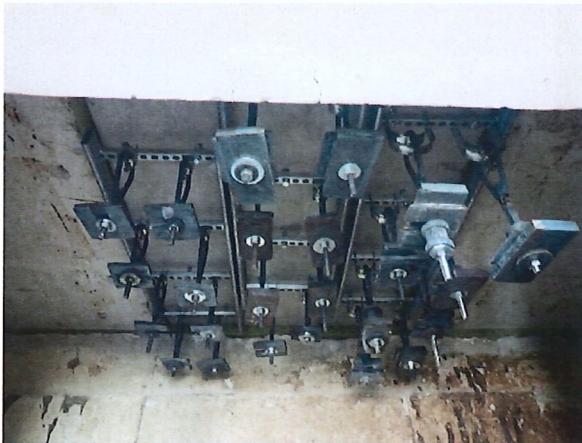
Figure A4.3 View of the clamps in the test furnace.

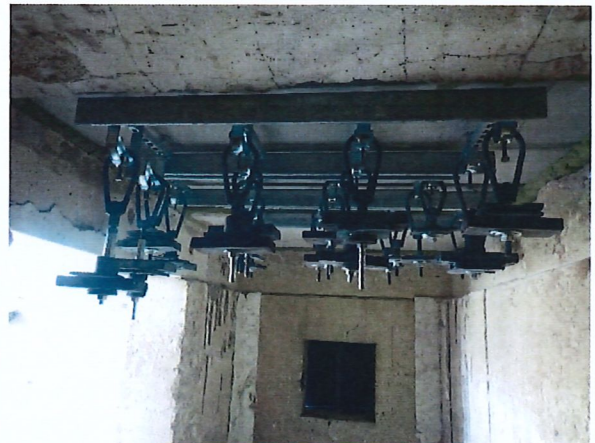
Figure A4.4 View of the clamps in the test furnace.

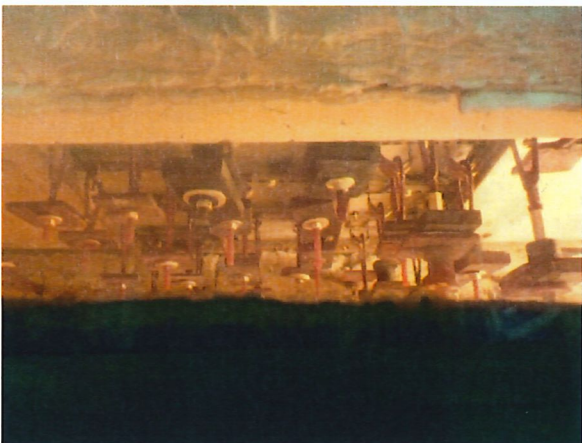
Figure A4.5 View of the clamps in the 20th minute of test.

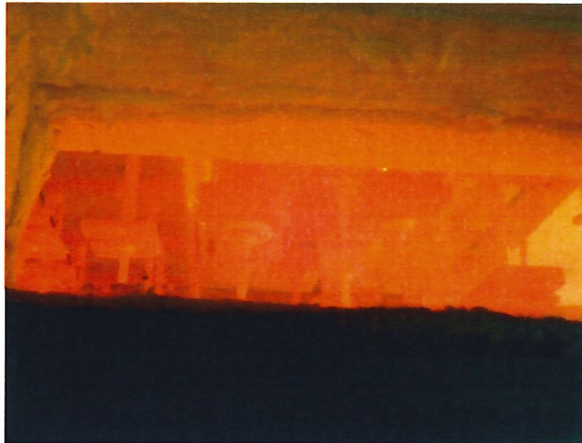
Figure A4.7 View of the clamps in the 60th minute of test.

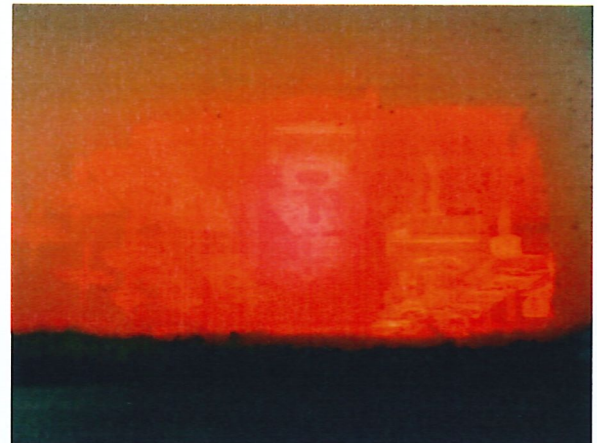
Figure A4.8 View of the clamps in the 90th minute of test.

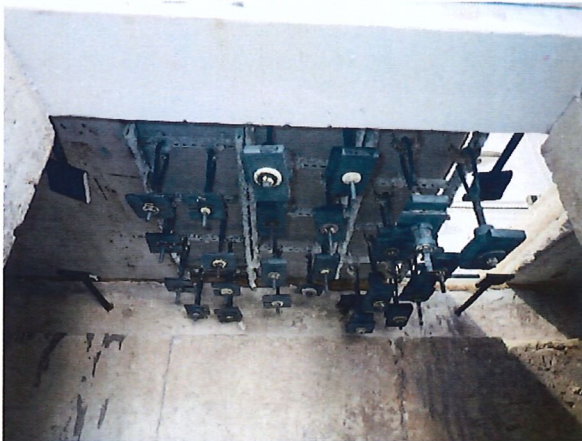
Figure A4.9 View of the clamps in the test furnace after the fire test.

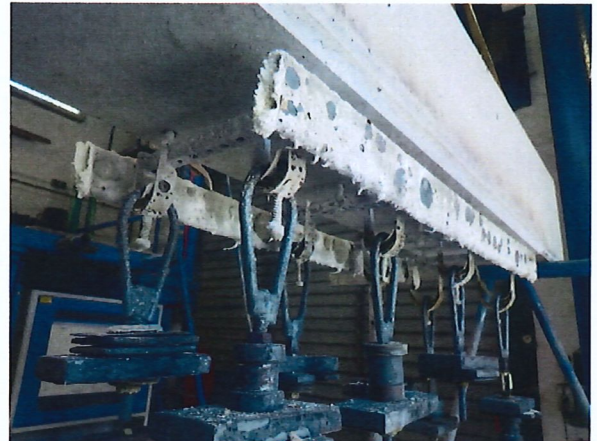
Figure A4.10 View of the test set-up after the fire test.

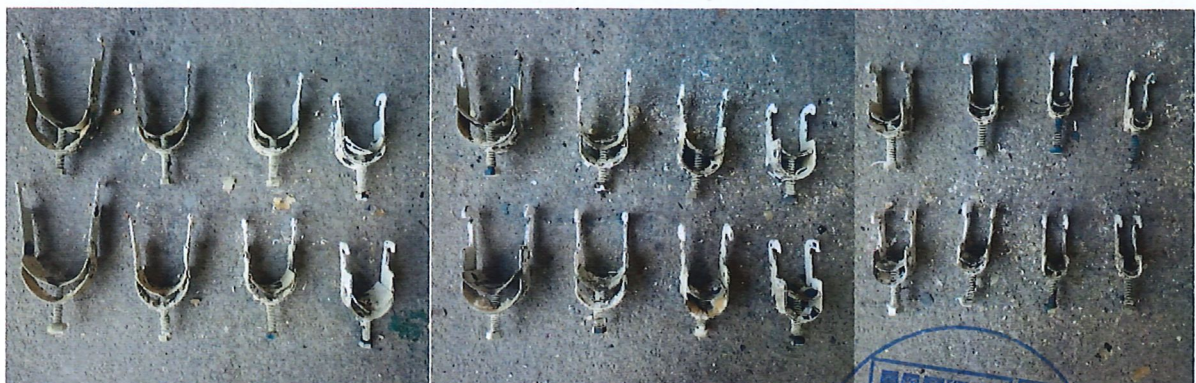
Figure A4.11 View of the clamps after the fire test.

The orienting fire test showed that the cable clamps with the relevant corresponding central loads, see table 1, did not fail under the influence of thermal stress according to the standard time-temperature curve (TTC). This means that the type "KP" cable clamps with the sizes and loads which are shown in table 2 have a fire resistance period above 90 minutes.
